# **Landowner Handbook**

**A road map for reconstruction,  
management, and long-term maintenance**

**Santa Clara River  
Washington County, Utah**

**Prepared by:**  
Natural Channel Design, Inc.  
3410 S. Cocopah Dr.  
Flagstaff, AZ 86001

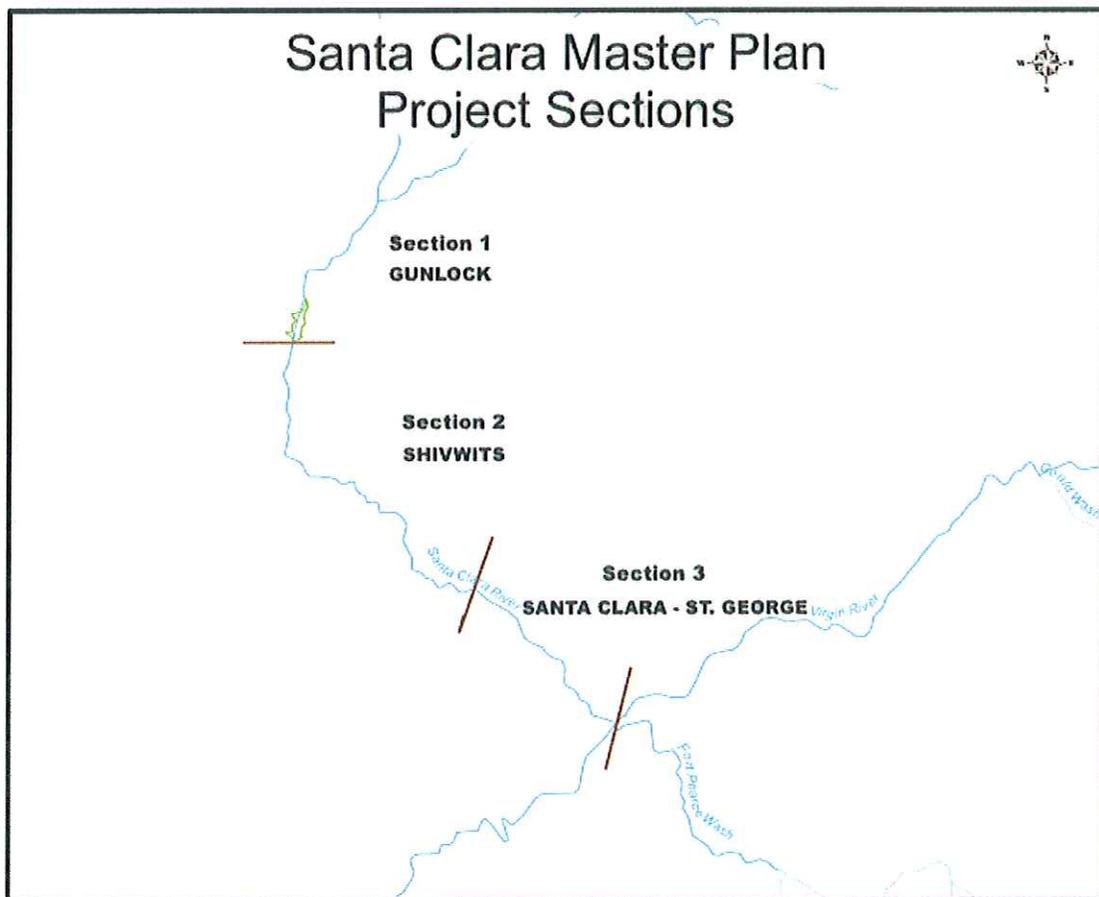
Figure 2-1. Map of Project River Sections along Santa Clara River

Several of these areas were further divided into smaller units (reaches) to facilitate assessment and recommendations.

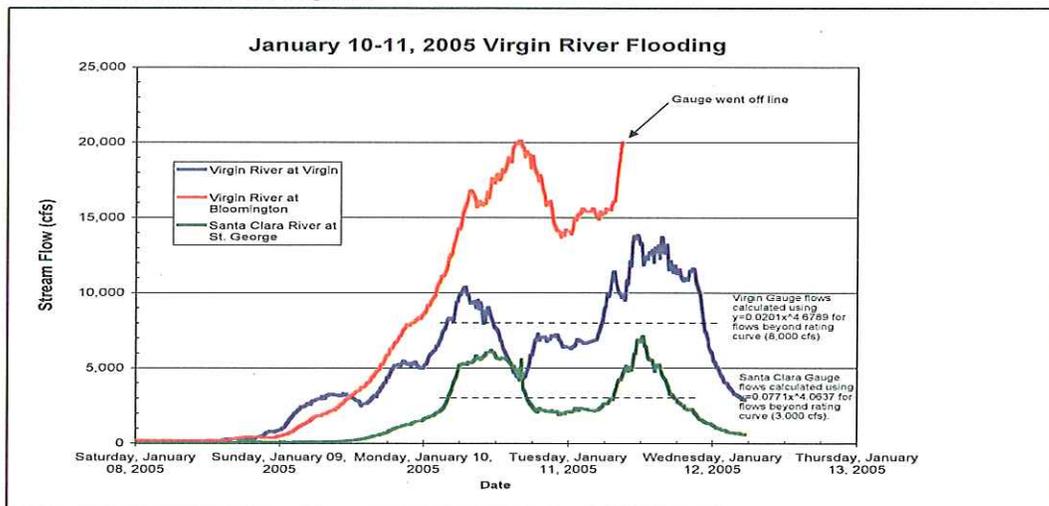
Figure 2-2. Reconstruction of January 2005 flood flows. (Cram, WCWCD)

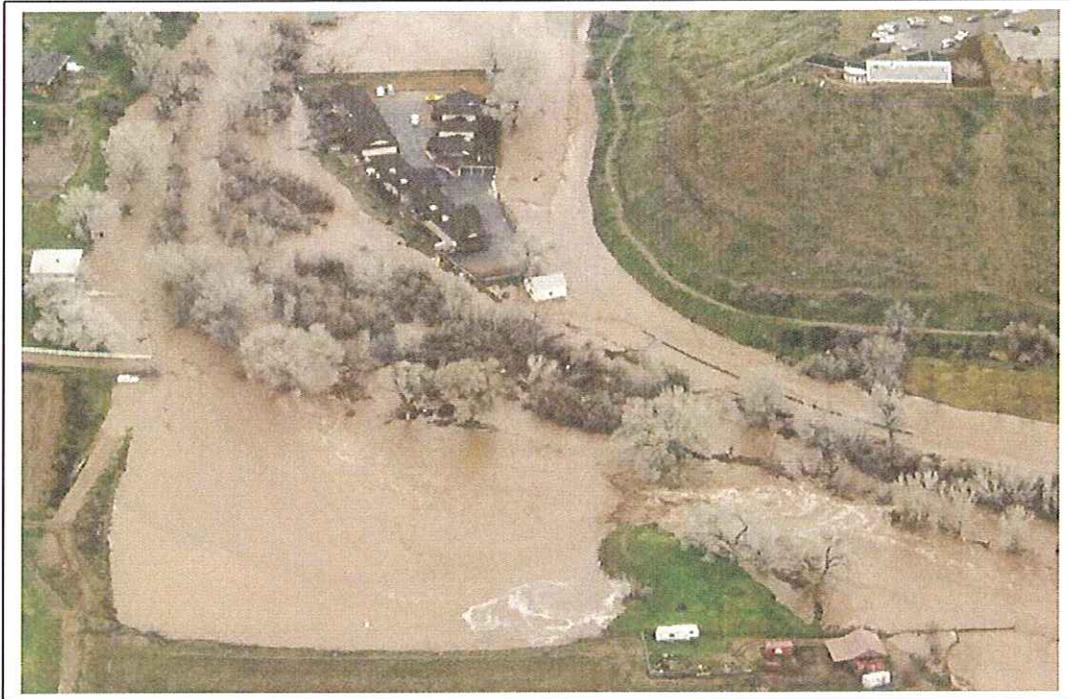
Figure 2-3. Debris blockage. Below Swiss Village the pre-flood stream ran through the dense stands of cottonwood and saltcedar trees. Once the channel was blocked, high velocity flows were diverted against the near bank eroding the erodible agricultural field. The entire area in the lower portion of the photo was eroded during the flood. (Rick Rosenberg photo)

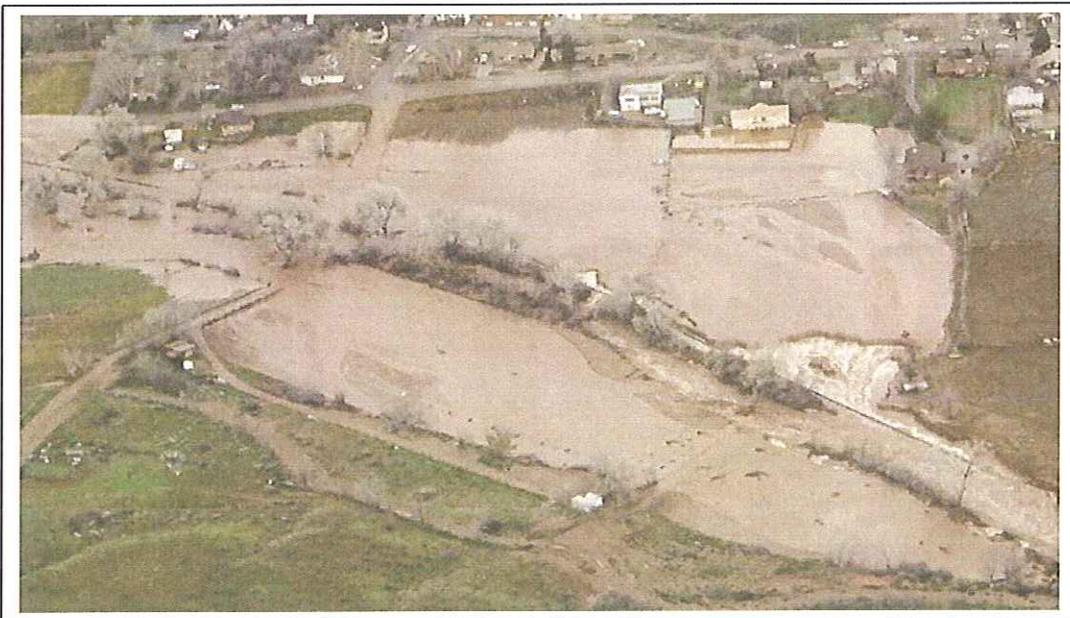
Figure 2-4. Overbank flows. Although the central channel remains open, overbank flows spread across open fields and reenter the river several hundred feet downstream. The elevation change at the reentry point creates a headcut that erodes the fields on one or both sides of the channel. (Rick Rosenberg photo)

The second mechanism was created when overbank flows were separated from the main channel by vegetation, structure or topography (Figure 2-4). The elevated overbank flows reentered the channel downstream forming powerful headcuts when reentering the main channel. The headcuts migrate upstream substantially widening the channel. The relatively smooth, flat surfaces of agricultural fields adjacent to the stream corridor created conditions for high overbankflow velocities and accelerated these events.

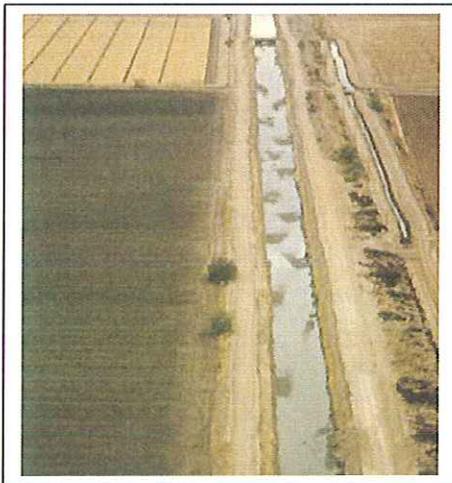
Figure 3-1. Alternating bars in a constructed canal demonstrates meander within straight channel.

All channels have a characteristic meander or pattern (Figures 3-1 & 3-2). Low gradient streams are more sinuous than steep ones. The lateral extent, frequency, and radius of curvature are a function of flows, sediment supply, slope, and bank material. Meander allows a low gradient stream to dissipate energy. In gravel streams, bedforms (riffles, pools, and runs) are closely correlated to channel pattern.

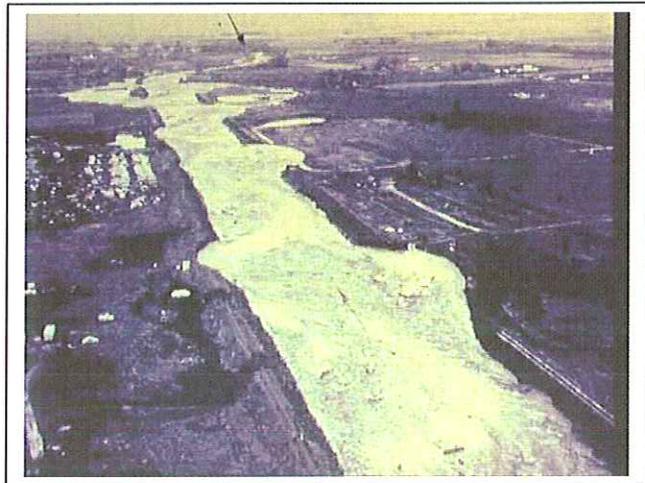
Figure 3-2. Meander pattern in Walla Walla River. Flood waters erode dikes to restore stream channel pattern.

Often stream channels are straightened in an effort to increase sediment transport, utilize additional lands or decrease lateral movement. However, the loss of meander increases stream power raising the potential for the stream to erode banks in an effort to dissipate energy. In addition, the stream's natural tendency to restore its characteristic meander pattern will also contribute to stream bank erosion. Without armoring, the stream channel will simply return to its pre-modified condition (Figure 3-2).

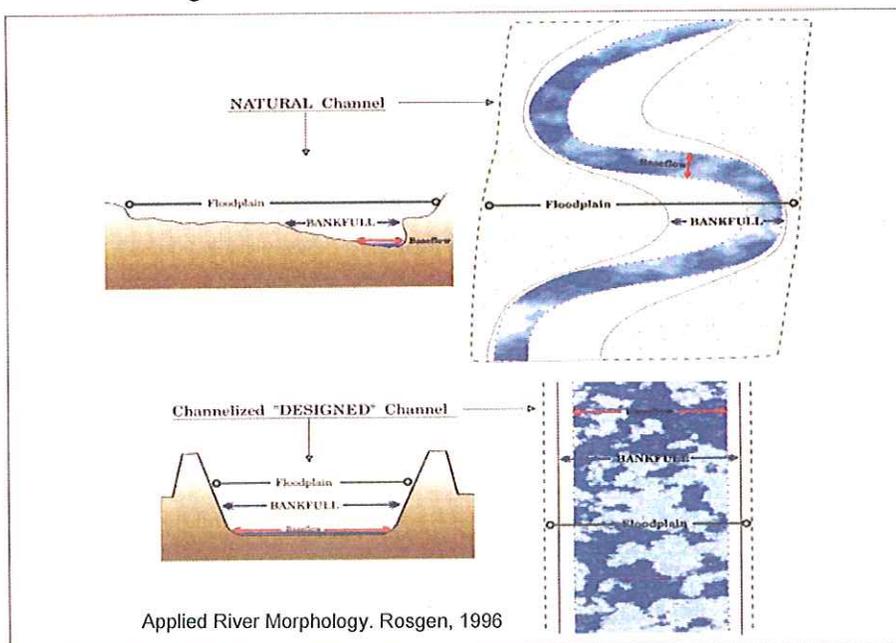
Figure 3-3. Natural vs. "Designed" Channels. The lack of geomorphic floodplains in the "designed" channel reduces sediment transport.

Channel widening is generally intended to increase the capacity of a stream to carry flood flows (Figure 3-3). Initially this is the case. However, overwidening of the bankfull or central channel decreases sediment transport. In channels with meander, point bars will build restoring pre-modification channel width and geomorphic floodplain elevation and negating the modification. In straightened channels, sediment deposition over time can raise the channel bed decreasing capacity and increasing the risk of flooding. Channel aggradation also increases the tendency to meander increasing the risk of bank erosion.

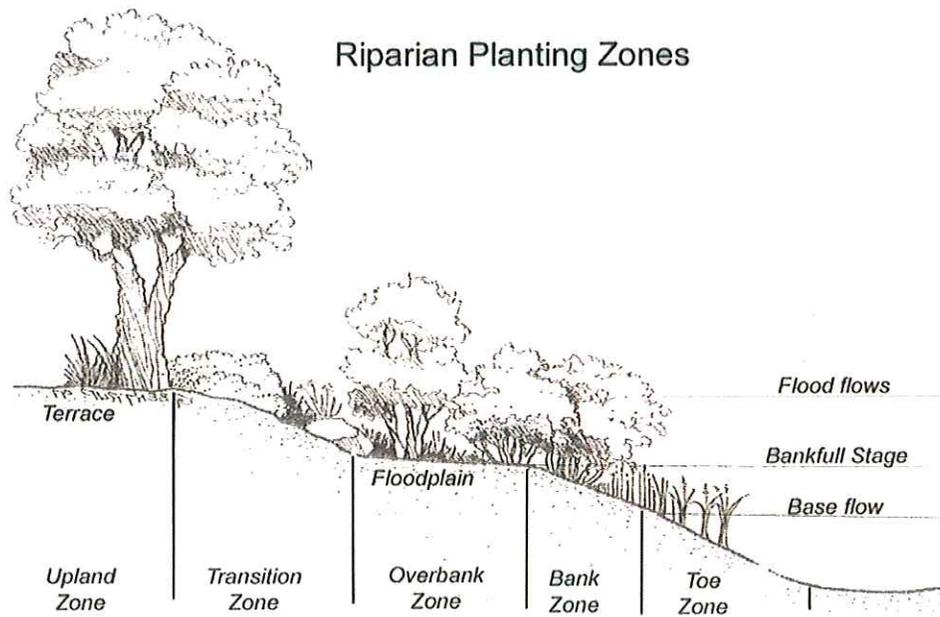
Figure 3-4. Riparian Planting Zones

Researchers at the NRCS Plant Materials Center in Idaho have divided the riparian corridor into discreet planting zones: Toe, Bank, Overbank, Transition, and Upland (Hoag, et al, 2001). Each zone supports a different community complimenting stream processes and creating habitats (Figure 2-4). For example, the toe zone adjacent to the perennial flow supports lush, wetland plants, the bank and overbank zone is dominated by grasses and shrubby willows, and the transition zone supports more arid grasses, shrubs and trees. The stiffness of vegetation (and associated roughness) generally increases as it moves away from the central stream channel.

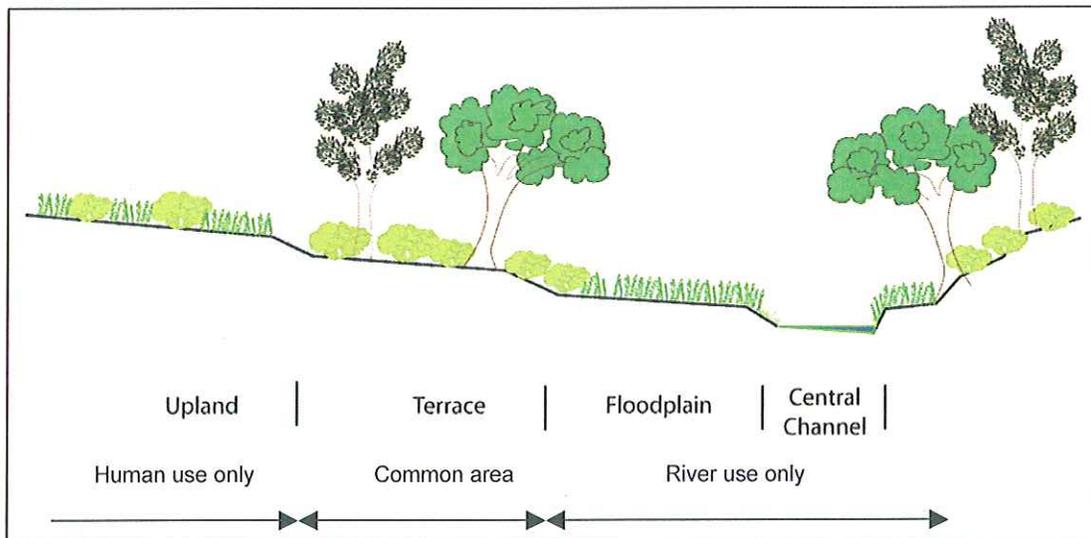
Figure 3-5. Areas of Use

The second area includes the low and high terraces and bars above the flood plain. These areas are inundated by Moderate and High floods but can be used for parks, agricultural fields, and recreational areas. This common area can be used by both the river and humans. Flooding will periodically scour areas and deposit sediments but damage should be manageable. No permanent structures should be constructed in these areas. Structures can constrict and/or redirect flows destabilizing the stream and creating additional flooding and erosion risks.

The final area includes lands that are above the level of all river flooding. These areas belong to humans and can contain houses and other permanent structures.

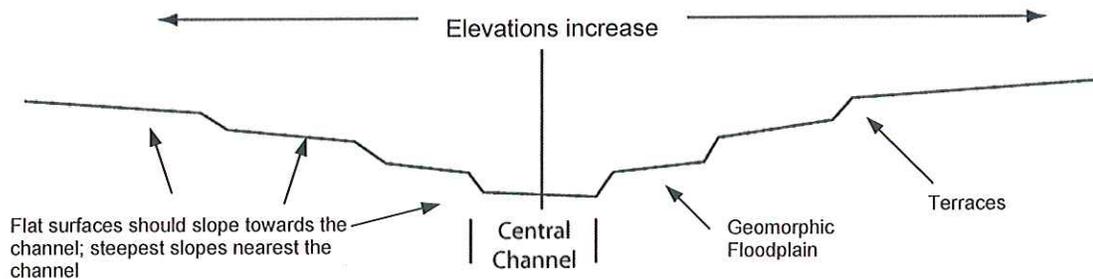
The central channel flowline must be the lowest point across the riparian area and the channel banks, floodplains, and terraces should slope upward continuously away from the channel. The banks will be most stable if they can be stepped as they rise away from the channel. For the Santa Clara steps of approximately 2 feet are recommended. Slopes at these steps should be 3:1 or flatter. All flat areas should slope toward the river. If they are level or slope away from the river they will tend to divert overbank flows away from the main channel and could contribute to greater erosion. Banks on the outside of meanders are expected to rise more rapidly than those on the inside but should still be stepped if at all possible.

Figure 3-6. Appropriate channel/floodplain elevations

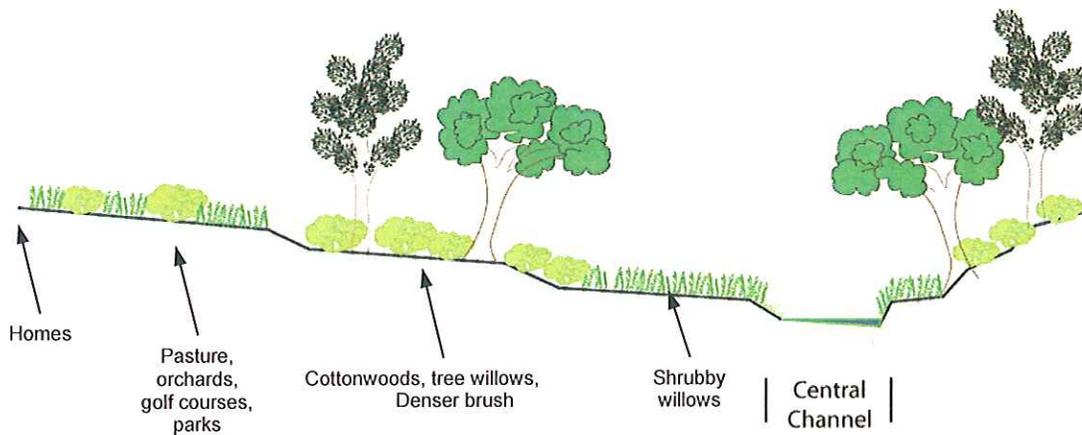
Figure 3-7. Appropriate Roughness. Vegetation provides increasing roughness to keep high velocities in central channel.

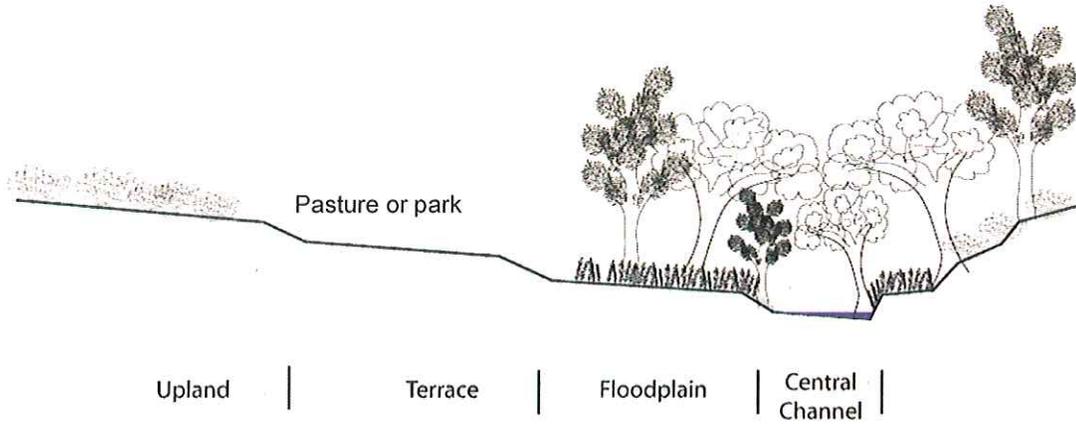
Figure 3-8. Incorrect Roughness. Dense stiff vegetation chokes channel. Smooth surface of pasture creates high velocities and erosion.

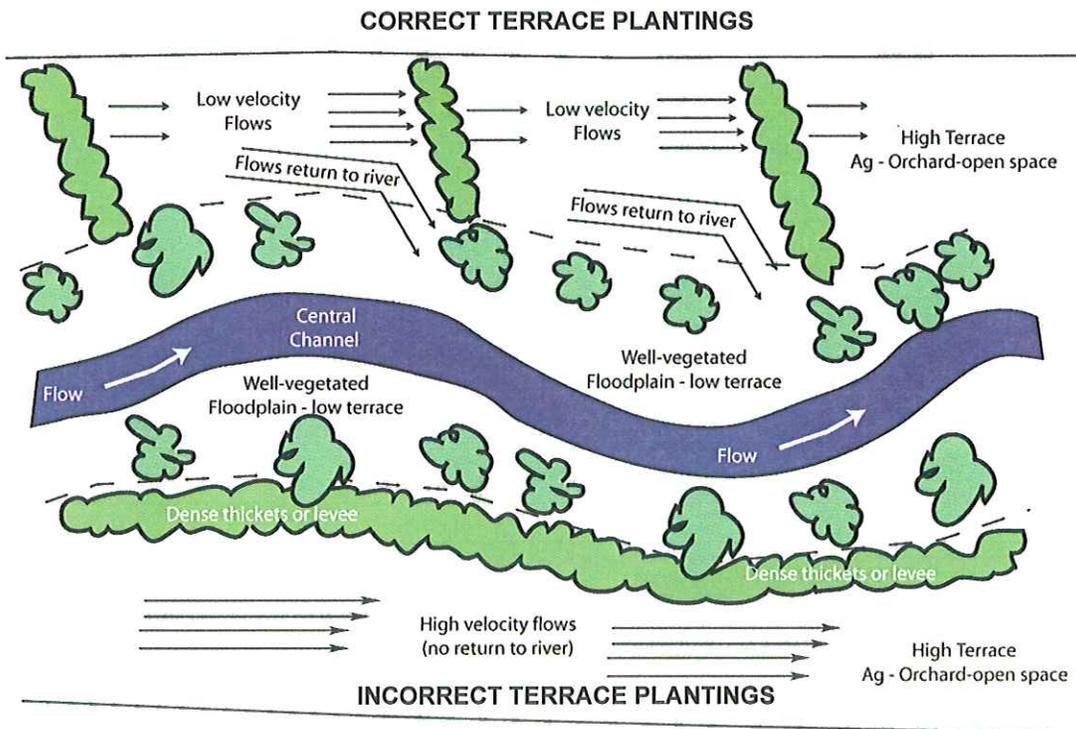
Figure 3-9. Terrace vegetation. Terrace areas used for pastures, orchards, parks or other areas with short, smooth surfaces increase erosional flow velocities. Vegetative buffers or hedgerows should be established to slow flows and redirect toward the river (top of figure).

Narrow, dense thickets of vegetation and/or levees parallel to the river should be avoided. These features trap erosional flows and inhibit return to the river (bottom of figure).

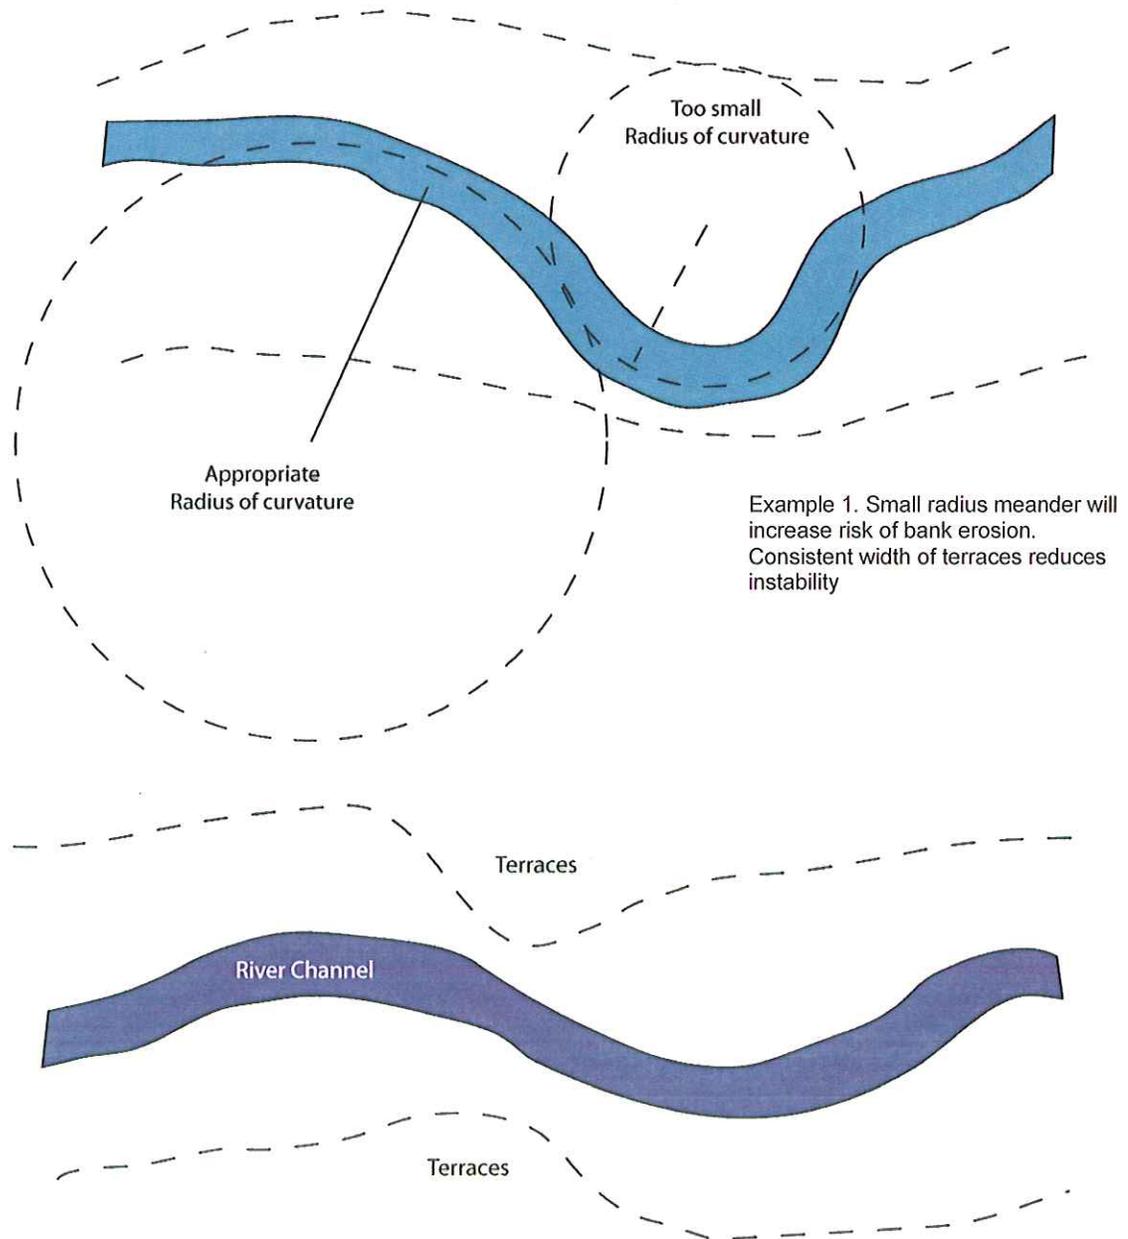
Figure 3-10. Incorrect transitions. Sudden narrowing of terrace or floodplain increases potential for erosion.

In order to minimize the risk of lateral bank erosion, water should flow smoothly through the stream corridor. While meander is a natural part of stream processes, tight turns can create excessive pressure to weak stream banks and increase erosion. Meanders should be gradual and within the dimensions described in specific recommendations. Floodplains and terraces should not be suddenly narrowed by buildings or other structures (Figure 3-10). Such constrictions force increases in velocity and water elevations that can increase erosion.

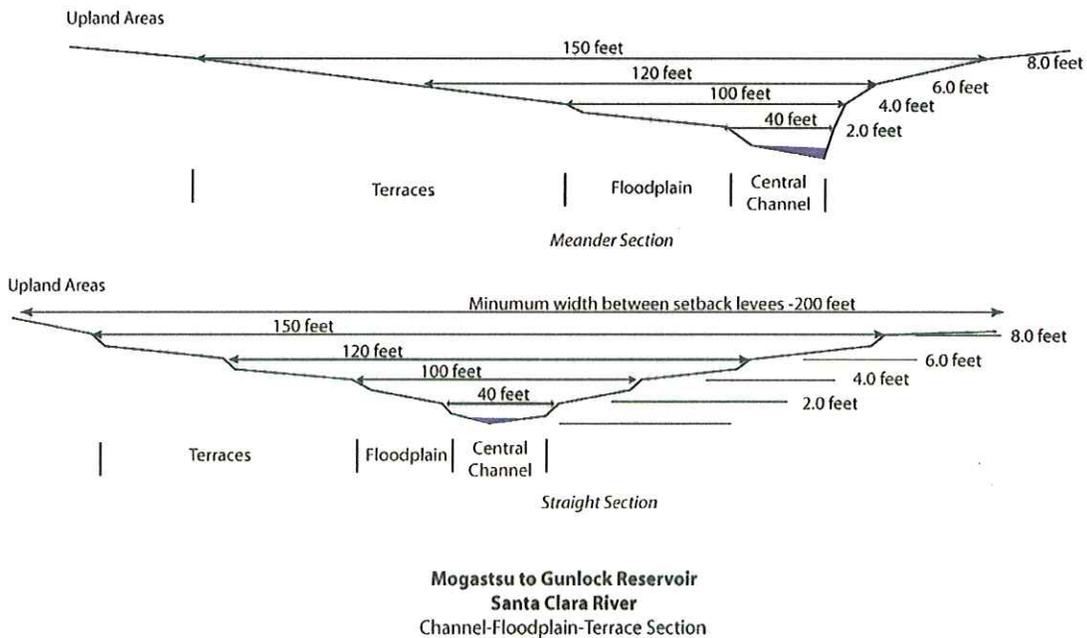
If setback levees are constructed to limit overbank flooding, the distance between setback levees should be no less than 200 feet.

Figure 3-11. Magotsu Creek/Moody Wash -Gunlock Dam channel template

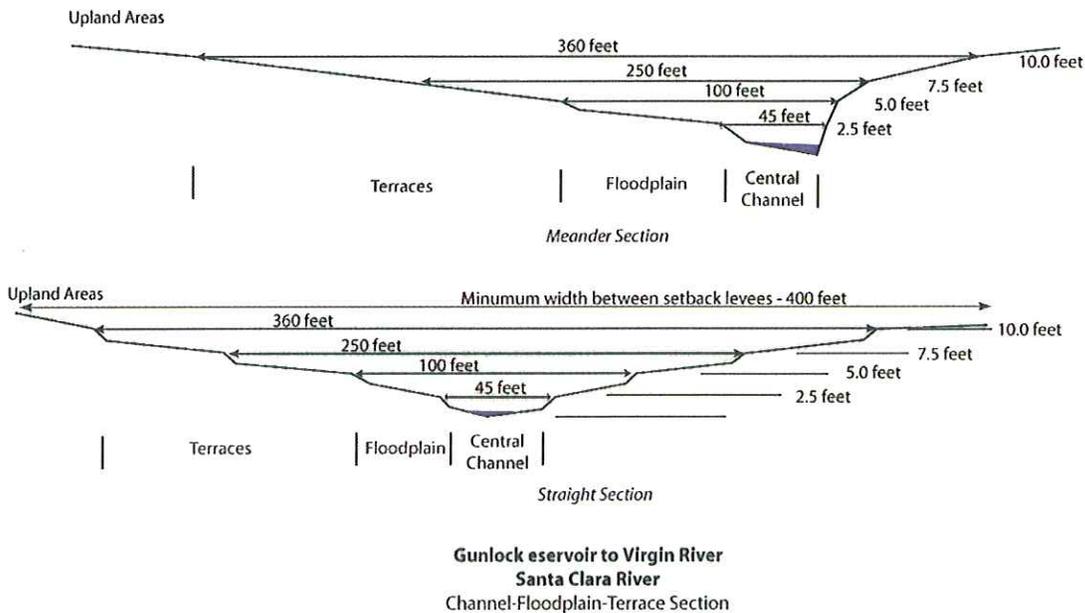
If setback levees are constructed to control overbank flooding, the distance between levees should be no less than 400 feet.

Figure 3-12. Gunlock Dam-Virgin River confluence channel template

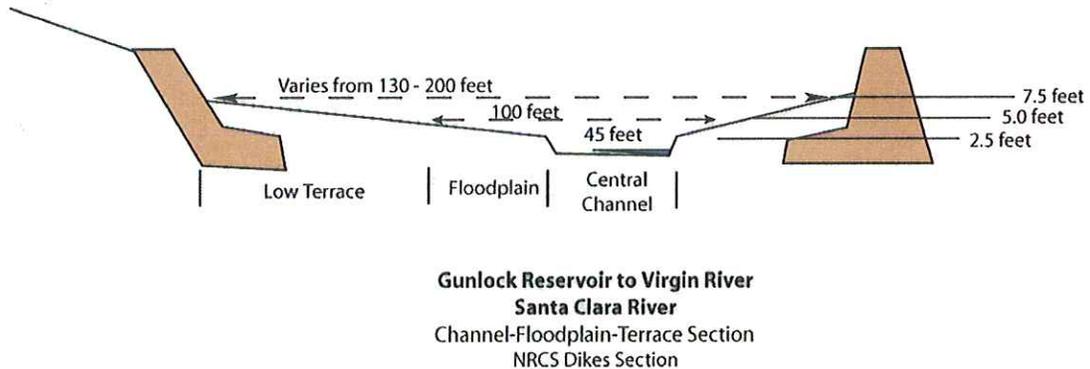
PARAMETERS		CHANNEL DIMENSIONS	
Channel Area	80 sq ft	Bkf Width	45.0 feet
W/D Ratio	25	Mean Depth	2.0 feet
Ent. Ratio	2.2	Max Depth	2.5 feet
Floodplain stage:	5 feet	Width	100 feet
Low Terrace stage:	7.5 feet	Width	Width between dikes
High Terrace stage:	10 feet	Width	NA feet

Figure 3-13. Channel template between NRCS dikes

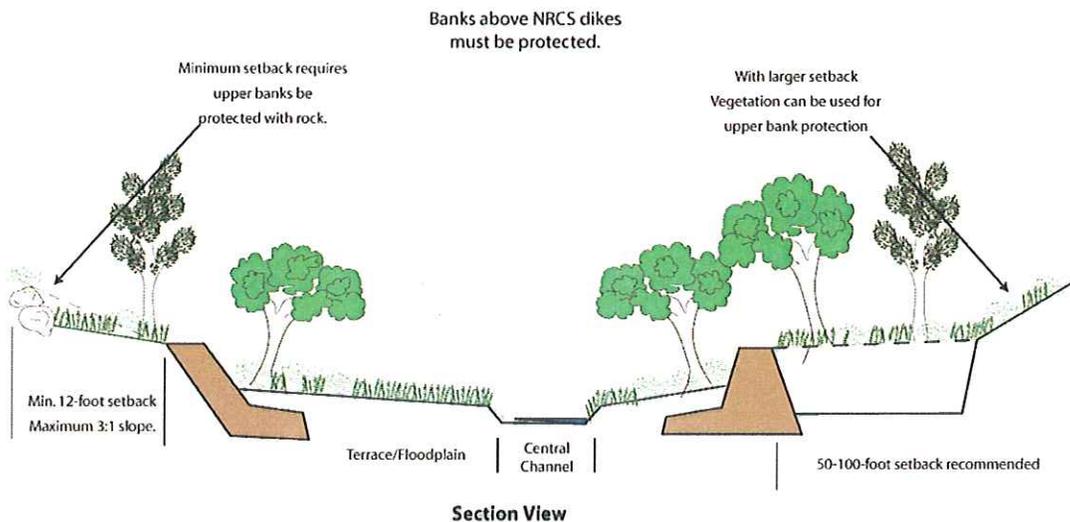
Areas behind NRCS dikes should be filled and revegetated whenever possible to minimize the risk of erosion. Based on the velocities and depth information generated from the hydraulic modeling, it is recommended that all structure and infrastructure be setback a minimum of 50 feet from the top of the NRCS dikes. The areas should be stabilized using strategies described in the Master Plan. Setback areas can be sloped or stepped up in one or more low terraces.

In areas where the minimum setback is not available, rock should be used to provide additional erosion protection to banks.

Figure 3-14. Setbacks in areas outside NRCS dikes

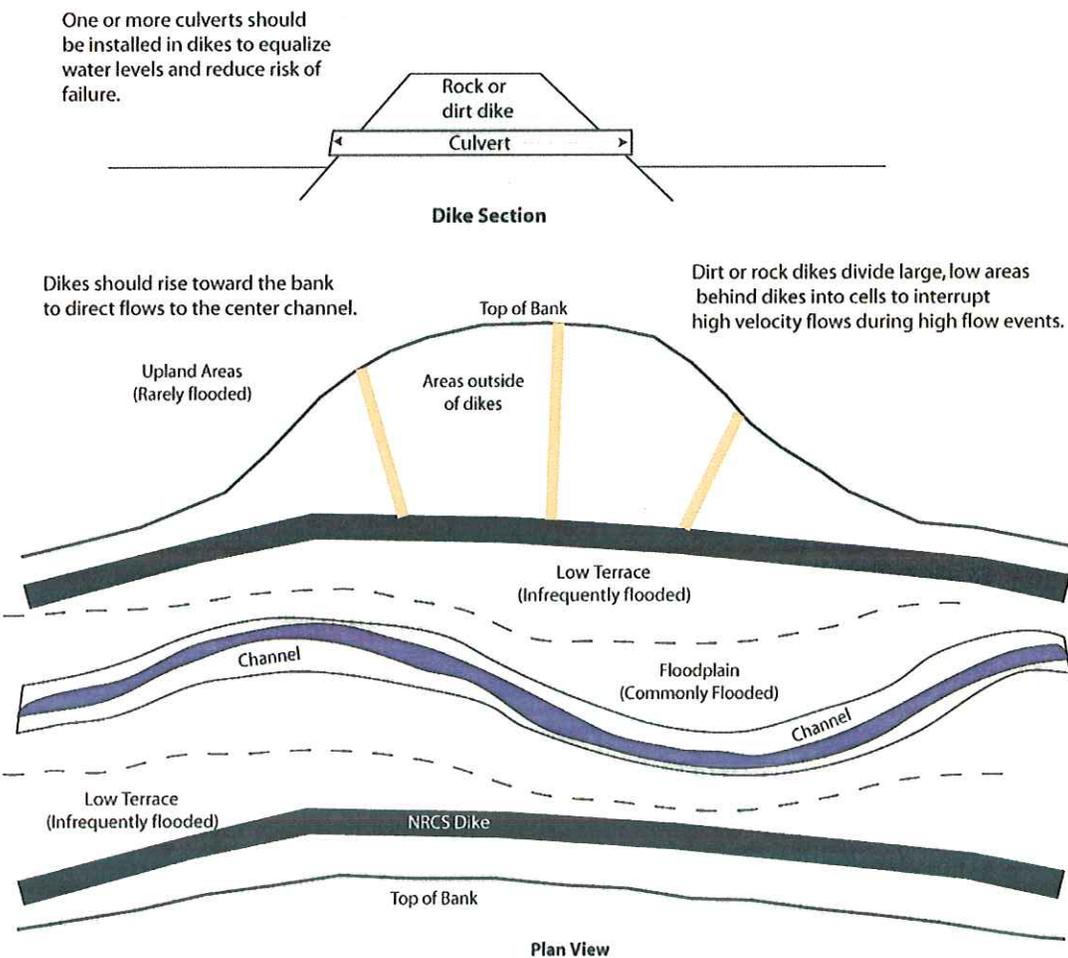
It is recommended that these areas be filled where possible to the elevation of the top of the dikes. The fill should rise in elevation as distances increase away from the dikes. Areas should be revegetated in accordance with the high terrace recommendations.

If complete filling is not feasible, the area can remain at an elevation below the top of dikes. However, it is recommended that dikes be installed across the areas to divide them into separate cells. The divisions will reduce the risk of erosive flows on the back side of the dikes. Culverts should be installed in the dikes to equalize water elevations between the cells.

The lower areas can be used as parks or agricultural fields. No structures should be constructed within the cells.

Figure 3-15. Strategies for large areas outside dikes.

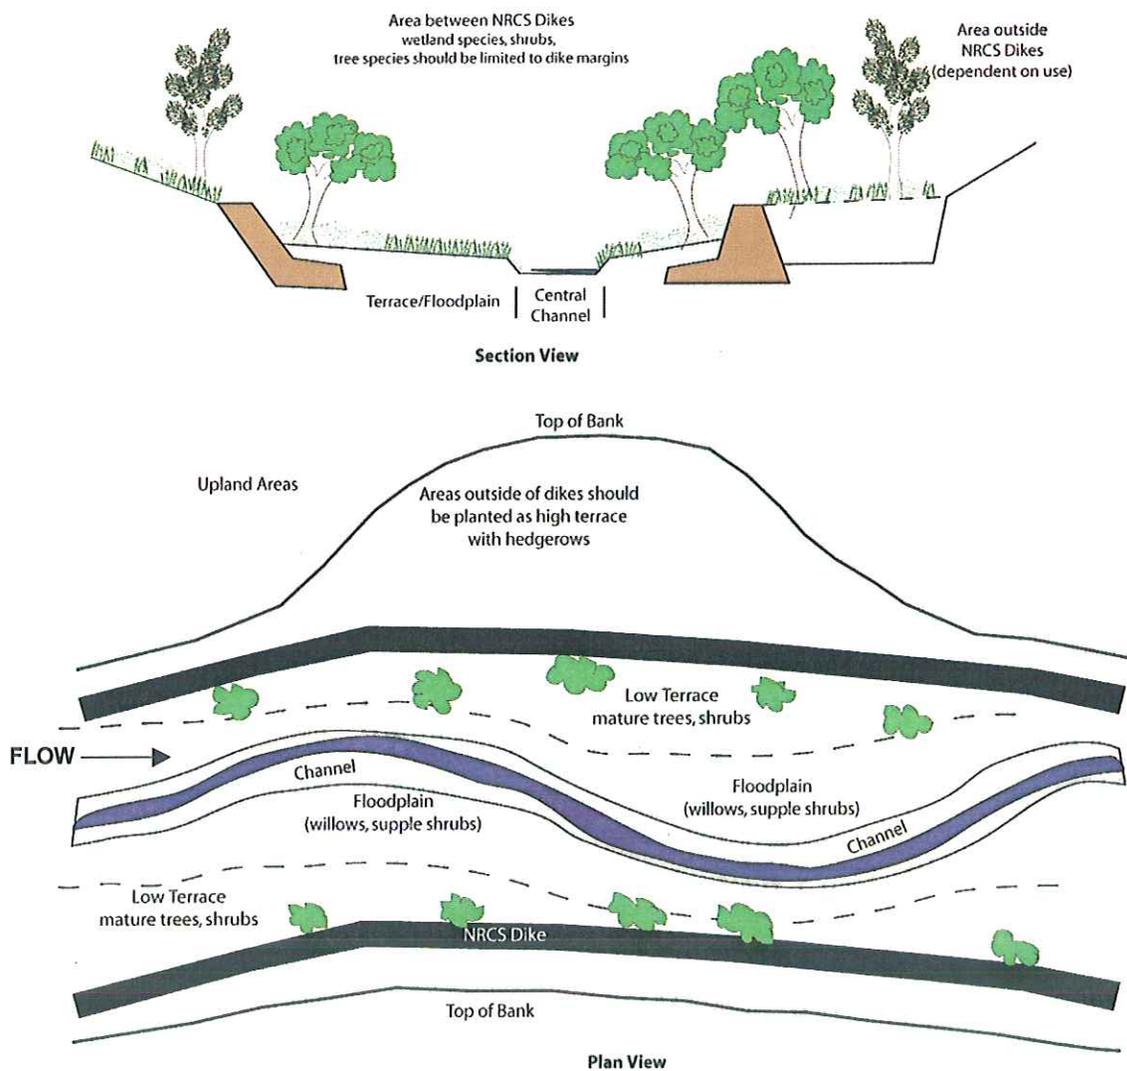
Figure 3-17. Riparian revegetation in areas with dikes.

***Areas behind NRCS dikes:*** the composition and distribution of plants should be consistent with recommendations for high terrace and upland areas.

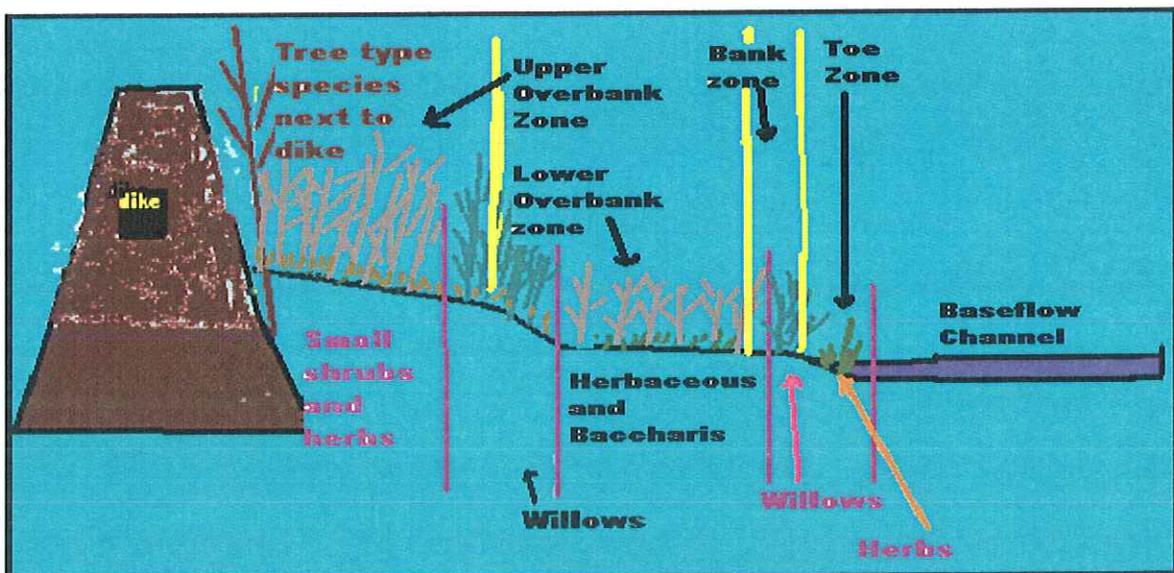
Figure 3-19: Plantings between dikes. A drawing of where to plant various types of plant species from the edge of the baseflow channel to the dike or undisturbed bank.

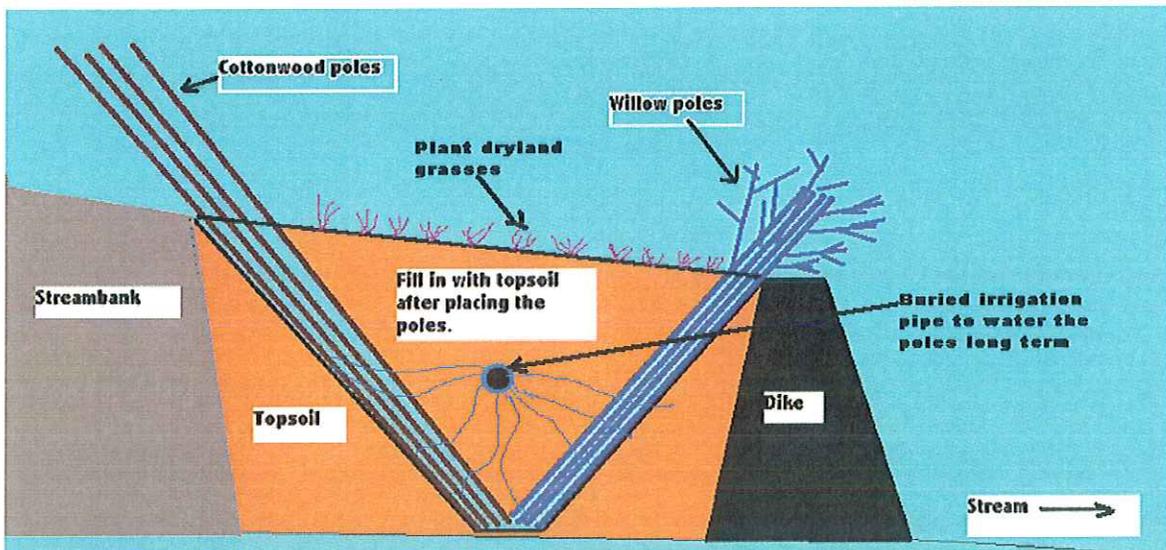
Fig. 39 Planting outside the dike in the 10 ft area between the dike and the streambank. Supplemental irrigation is necessary for the cottonwood.

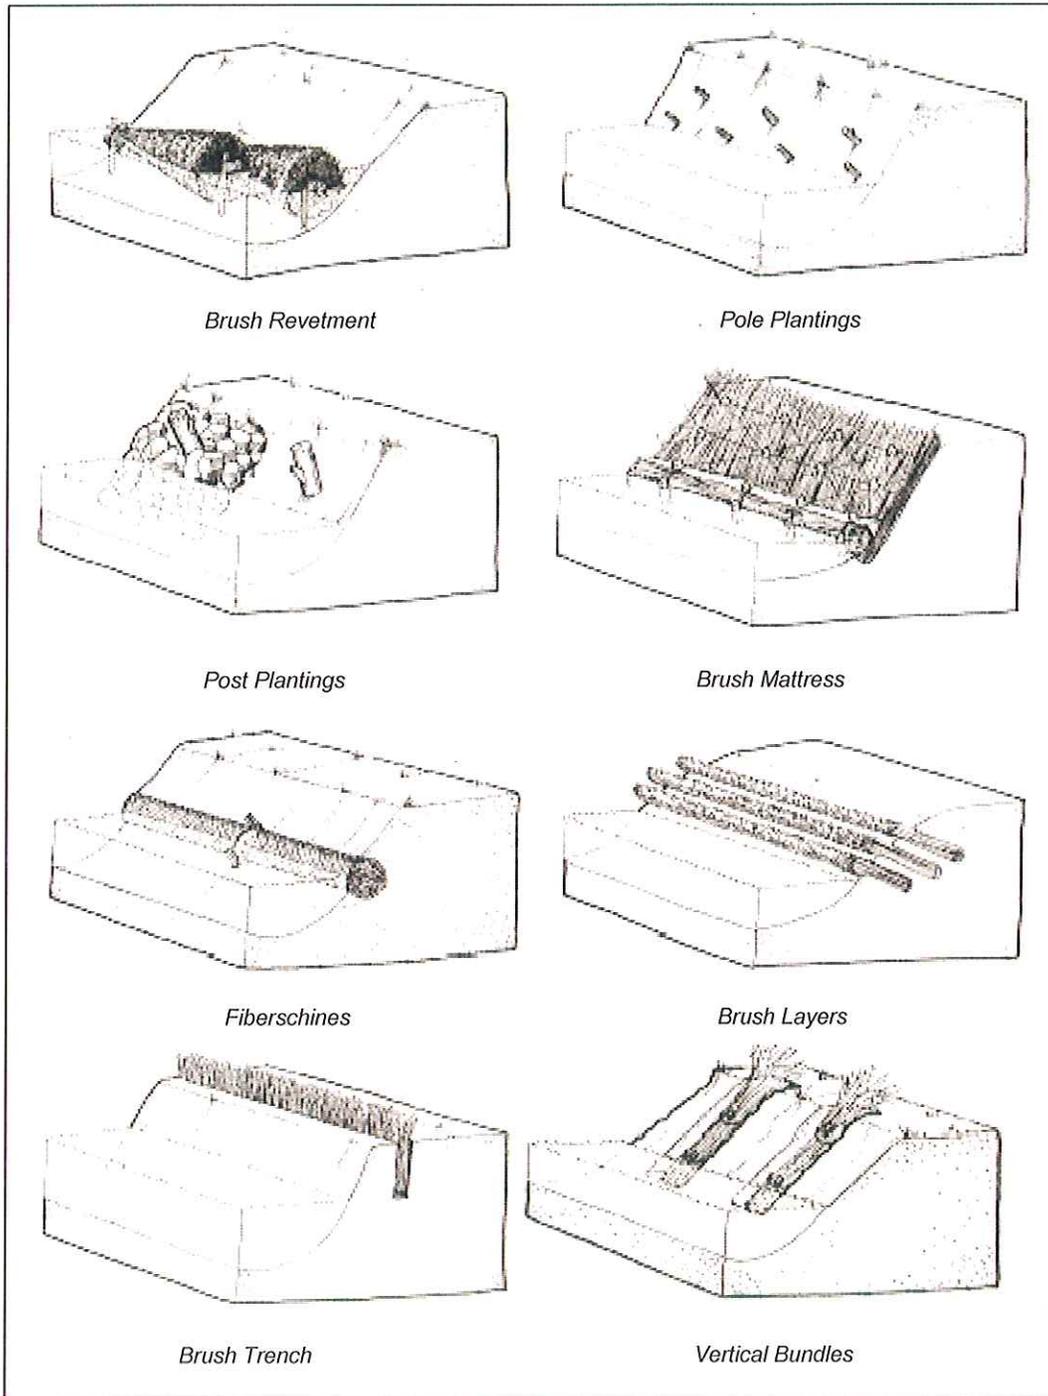
Figure 2-20 Engineering Practices.  
Source: The Practical Steambank Engineering Guide, Gary Entrup and JChris Hoag.  
USDA-Natural Resources Conservation Service, Plant Materials Center, Aberdeen, Idaho, 1998

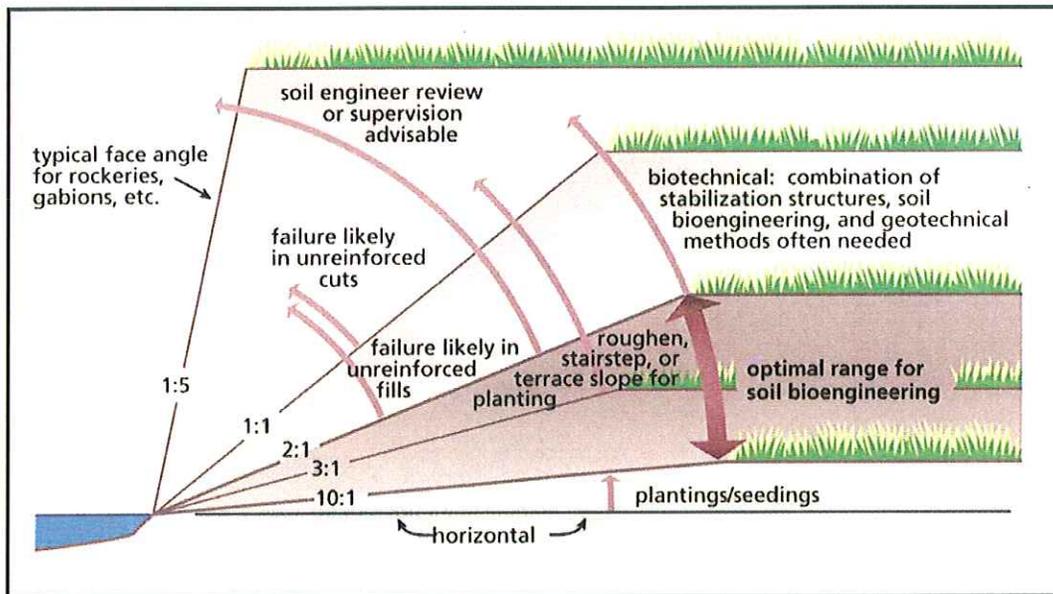
Figure 3-21. Stream bank slope stability. Stream banks with more gradual slopes are less erodible and easier to stabilize with native plant species. (Stream Corridor Restoration, Federal Interagency Stream Restoration Working Group).

Mechanical and/or manual bank sloping greatly reduces the erodibility of stream banks. Structural stabilization such as rock generally require slopes of 1.5: or less. Bioengineering is much more successful if slopes are less than 3:1. Not only are banks more stable but vegetation grows more vigorously on gradual slopes (Figure 3-21).

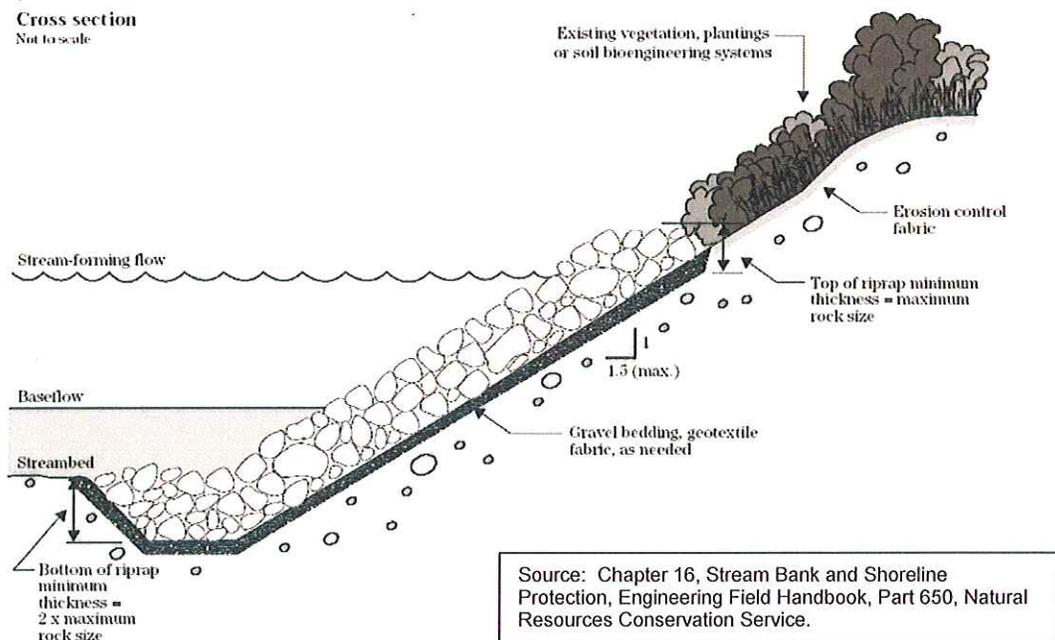
Figure 16-32 Rock riprap details

Figure 3-30. Toe Rock. This structural practice is generally installed along the outside of a meander bend to reduce the risk of lateral erosion.

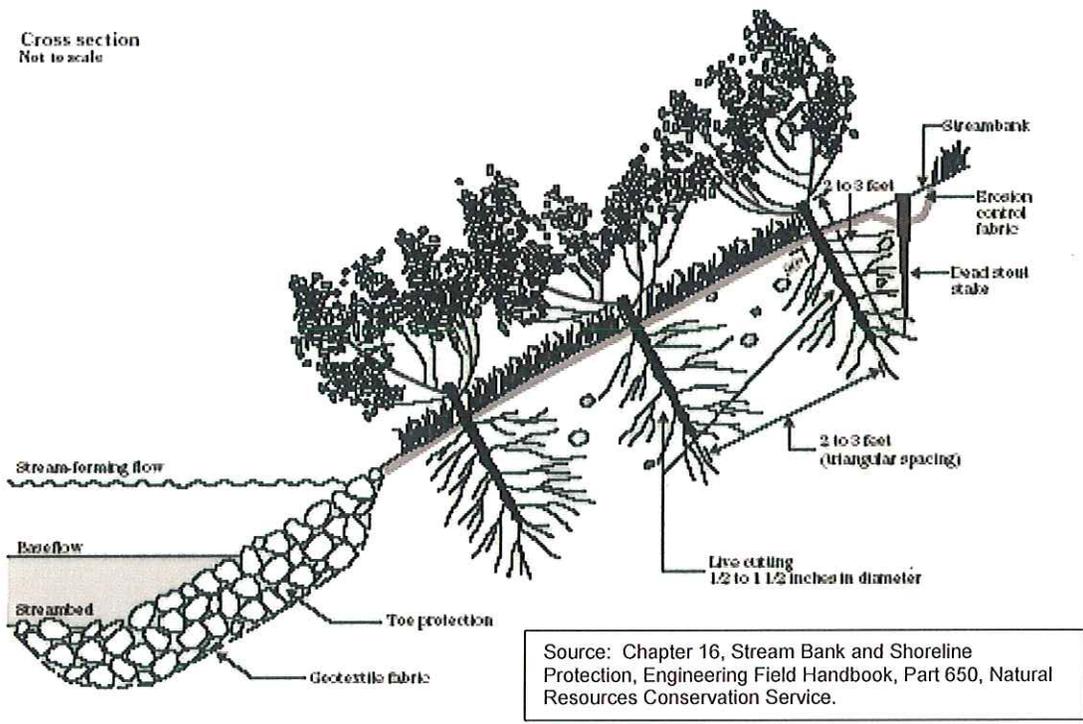
**Figure 16-4 Live stake details**

Figure 3-23. Live Stakes. This structural practice can be installed with or without structural stabilization.

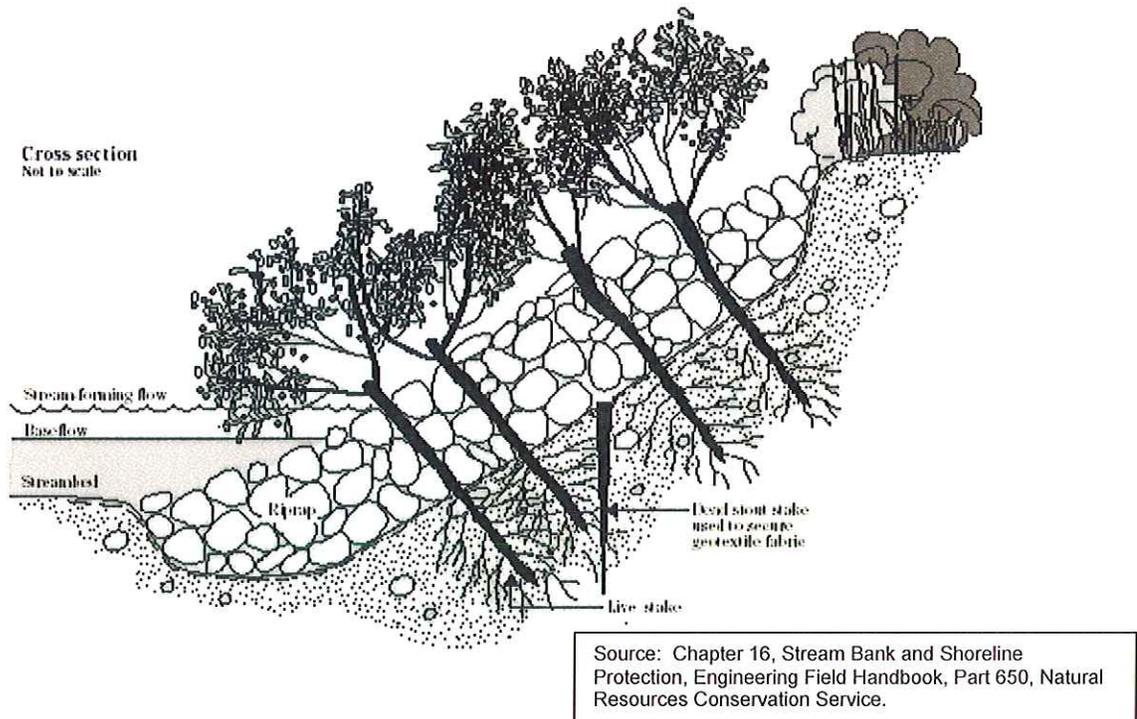
Joint planting or vegetated riprap involves tamping live stakes into joints or open spaces in rocks that have been previously placed on a slope (Figure 3-24). Alternatively, the stakes can be tamped into place at the same time that rock is being placed on the slope face.

Figure 3-24. Joint planting. Native vegetation combined with rock stabilization.

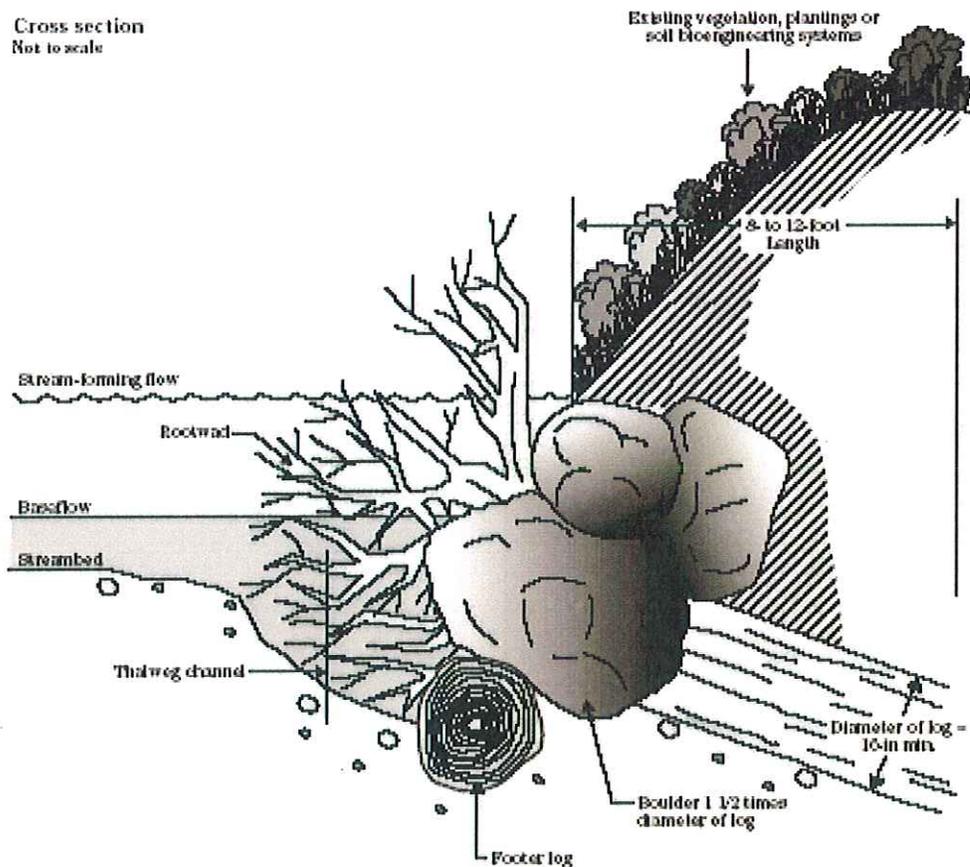
These revetments are systems composed of logs, rootwads, and boulders selectively placed in and on streambanks (Figure 3-25). These revetments can provide excellent overhead cover, resting areas, shelters for insects and other fish food organisms, substrate for aquatic organisms, and increased stream velocity that results in sediment flushing and deeper scour pools.
