# **Landowner Handbook**

**A road map for reconstruction,  
management, and long-term maintenance**

**Santa Clara River  
Washington County, Utah**

**Prepared by:**  
Natural Channel Design, Inc.  
3410 S. Cocopah Dr.  
Flagstaff, AZ 86001

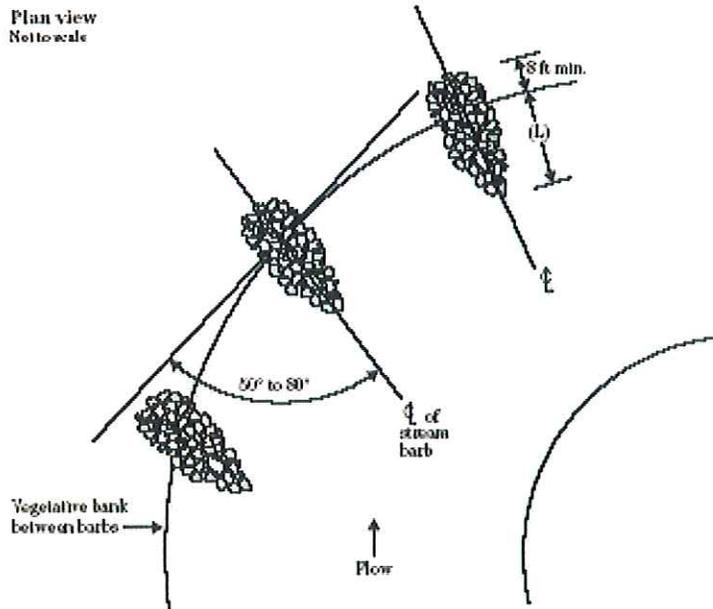
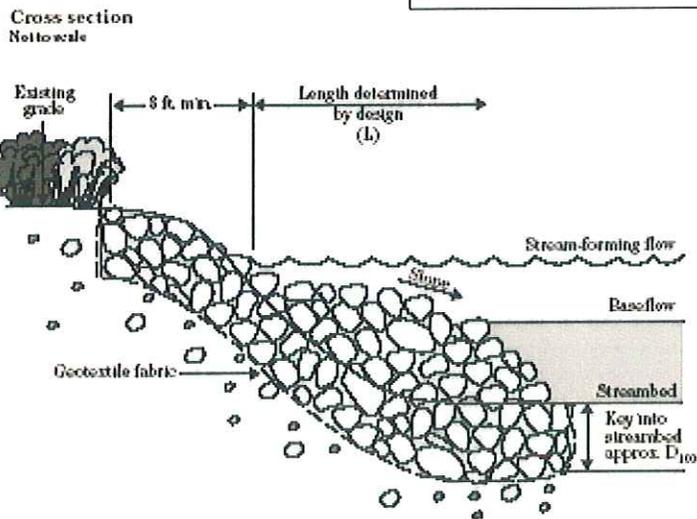
Stream barbs serve as an alternative to traditional rock armoring. Sometimes called vanes, the low structures redirect flows to the center of the channel reducing velocities against sensitive bank areas (Figure 3-26). The rock structures are angled upstream and dip downward from floodplain elevation at the bank to the channel bed. They never extend more than 1/3 of the way across the bankfull channel (Bogen 20). The structures are generally installed in series along the outside of a channel meander.

Figure 3-26. Stream barbs/rock vanes. These low structures redirect flows away from erodible banks and to the center of the stream channel.

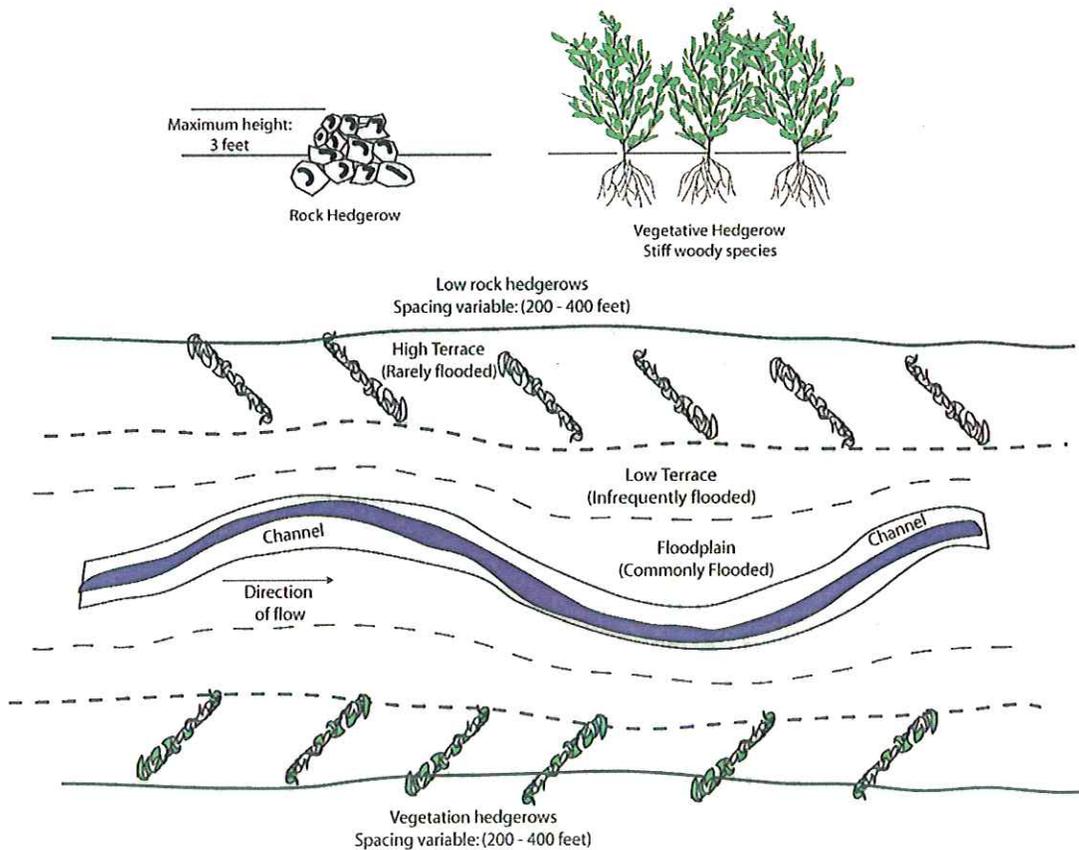
Figure 3-27 Terrace stabilization

Woody hedgerows can be created using native vegetation, ornamental hedges, or even grape arbors. Hedgerows can be planted between fields and along fairways and city parks. Hedgerows should never be planted in continuous sections parallel to the stream flow because they will reduce the ability for overbank flows to return to the river.

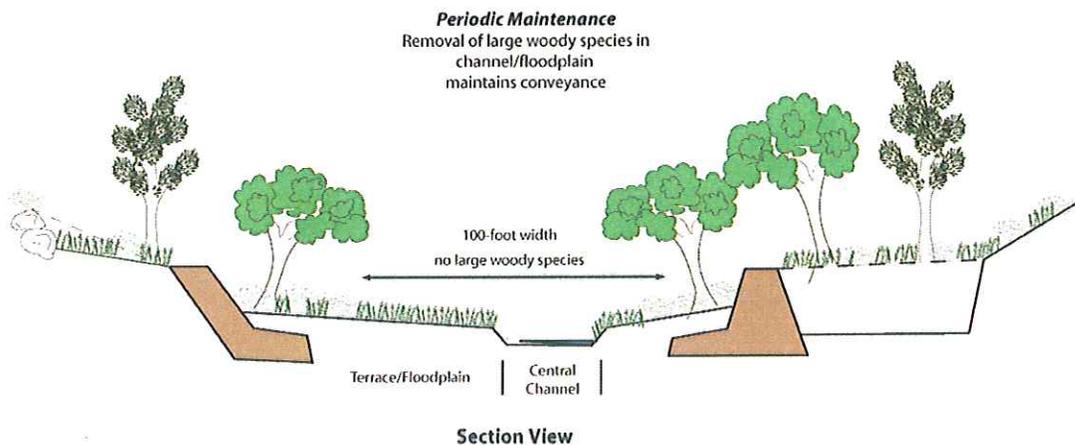
Initially, all channel clearing should be completed manually. If manual methods are found to be insufficient to maintain a clear channel, effective mechanical means can be evaluated that minimizes impacts to the native riparian vegetation and alluvial features.

Figure 3-28. Maintenance of Riparian Vegetation. Large woody species (>2 inches) should be trimmed from the channel and floodplain in areas with and without dikes.
